Navajo Abandoned Uranium Mine

Site Screen Report

Carson AUM Site

August 2010

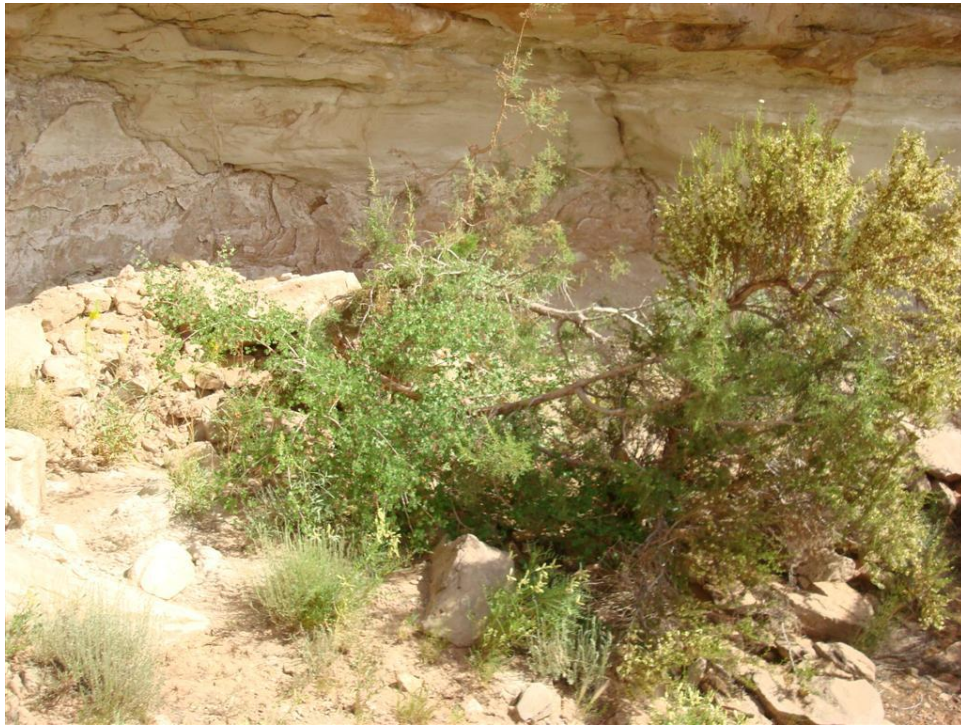
Photo 1. Carson mine site, wall area

A total of 3,669 gamma radiation measurements were collected from the mine site, ranging from 6,538 cpm to 308,495 cpm. Measurements in the vicinity of the side wall were found at levels of approximately 300,000 cpm. The measurements are represented in Figures 1 and 2.

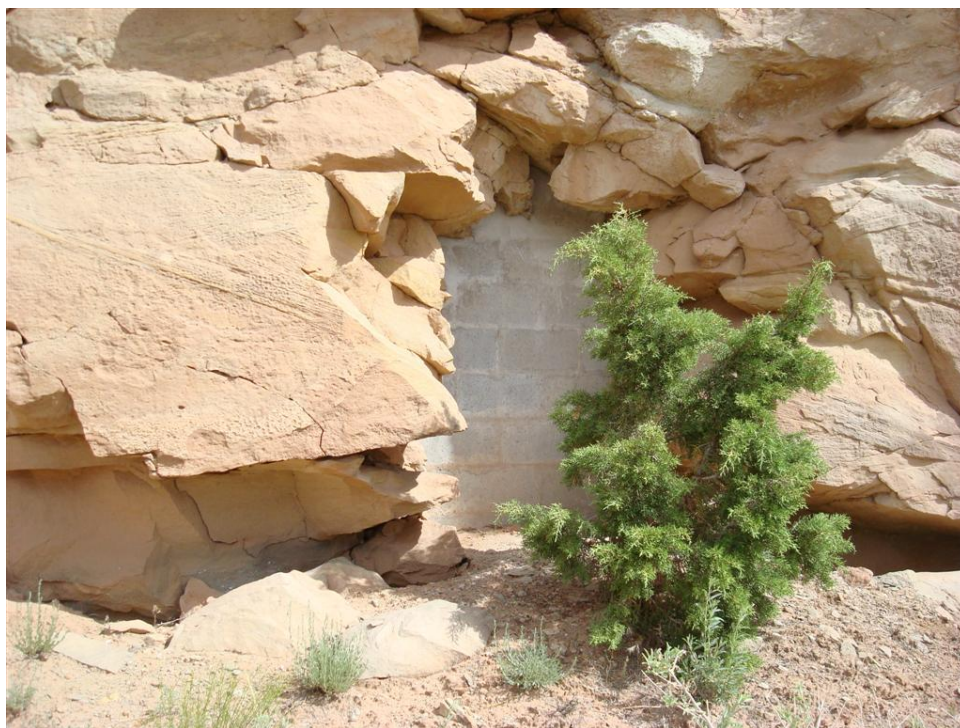
Photo 3. Carson mine site, adit 1

2 adits: adit 1 at base of lowermost resistant layer; adit 2 slightly north (100 ft) of adit 1; both sealed with mortar and concrete

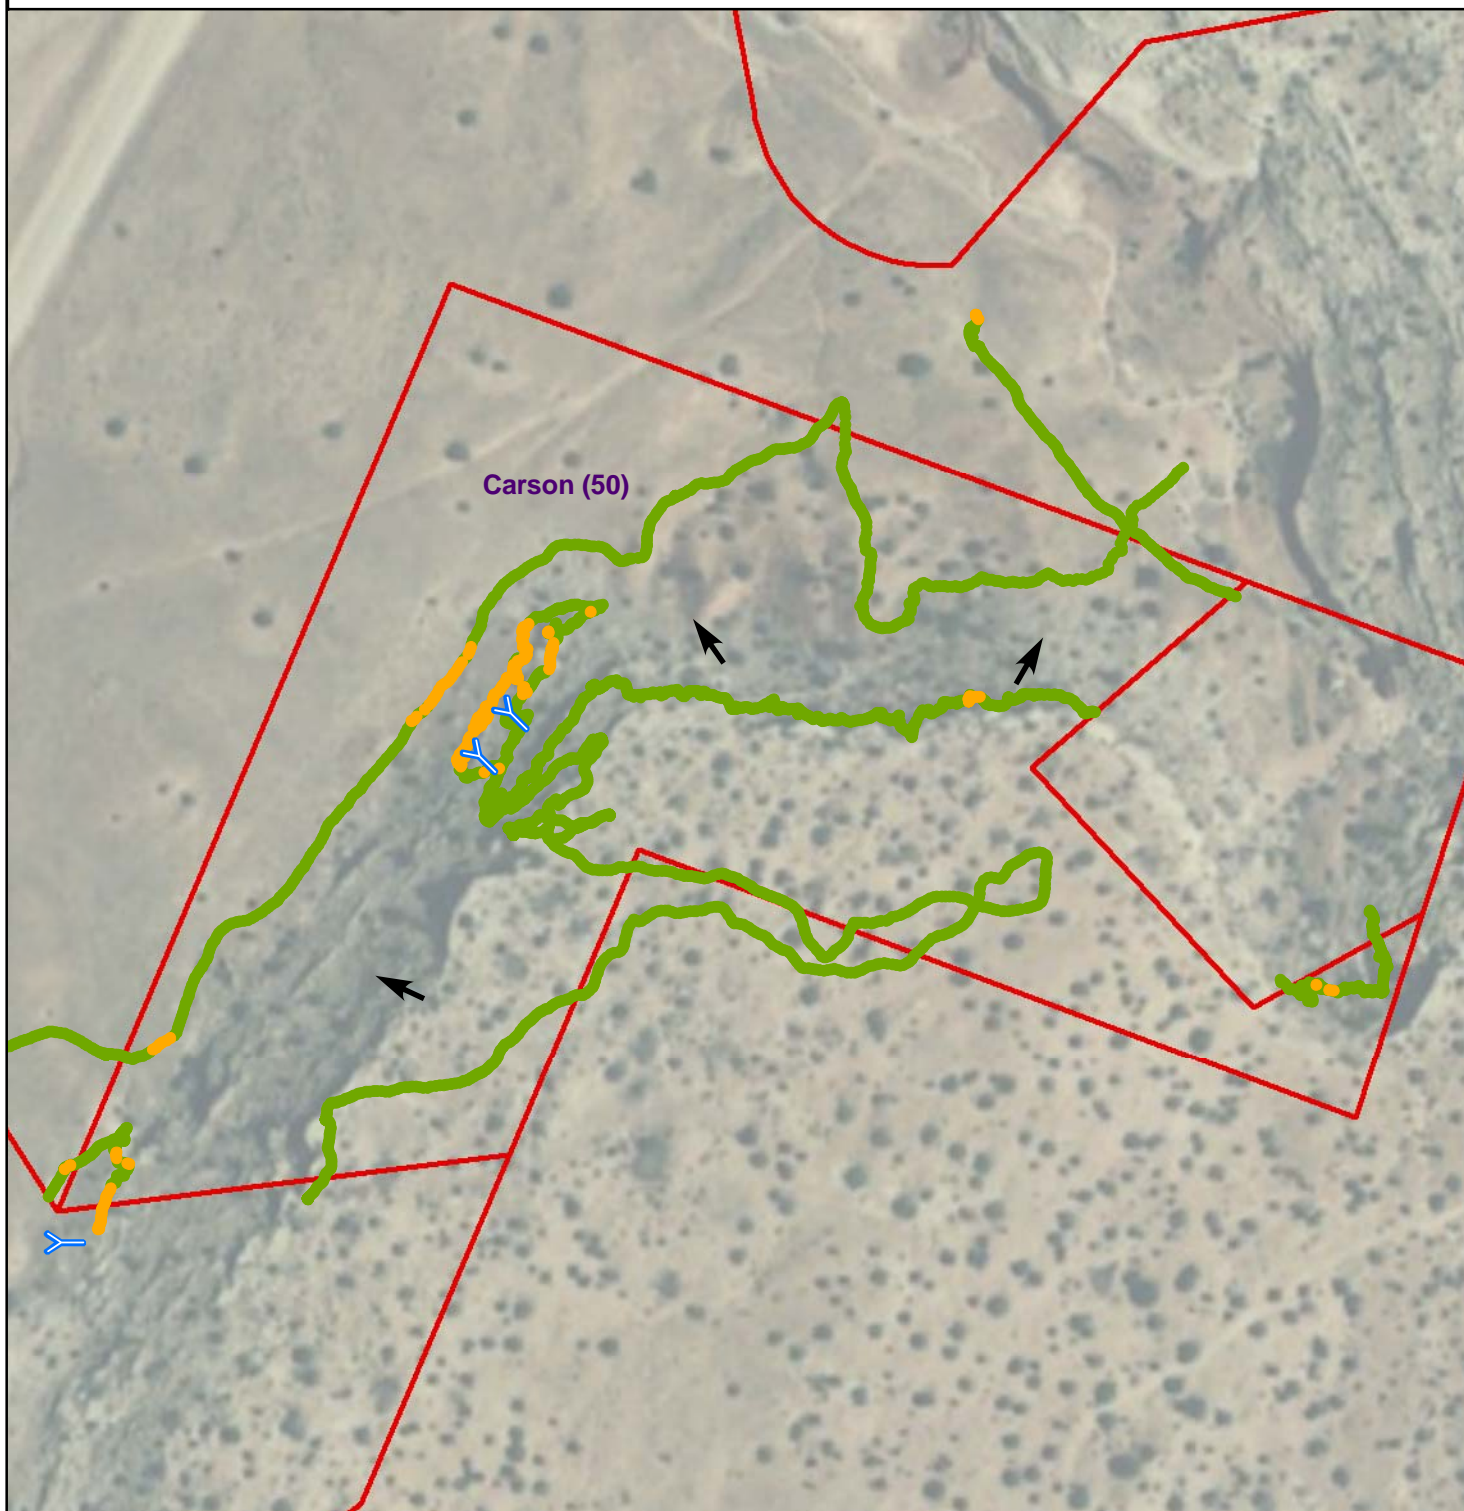
**Figure 1 - Gamma Radiation Measurements, Above Two Times Background
Carson (50)
Sweetwater / Teec Nos Pos Chapter, Navajo Nation**

Gamma survey conducted 06/2010
Measured as counts per minute (cpm)

Average background = 9,634 cpm
